Chandeleur Island Restoration

(Pontchartrain Coastal Lines of Defense Program)

Lake Pontchartrain Basin Foundation – Coastal Sustainability Program

Fact Sheet – Chandeleur Island Restoration

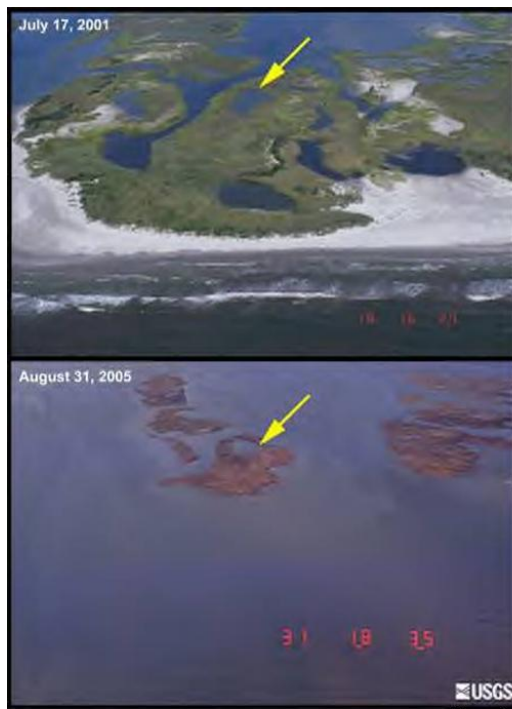
Oblique aerial photographs of a segment of the Chandealeur Islands in the easternmost area of the Pontchartrain Basin in southeastern Louisiana.

Arrows mark a common referenced location. The Chandealeur Islands are part of the Breton Island National Wildlife Refuge established by President Teddy Roosevelt in 1904. The islands normally function as a major bird rookery, which provides critical habitat for several endangered species.

The photographs were taken before and after four hurricane passages occurring between 2001 and 2005. Note the extreme overwash of the barrier island in which most sand (white area) was washed away. Much of the vegetated platform (dark area) was also eroded. The Chandealeur Islands do breach naturally and may heal themselves. Recent storm activity, such as Hurricane Katrina, has not allowed sufficient time for significant recovery of the islands. Long term, the islands have had a net reduction in areal extent resulting in a loss of important habitat and hurricane protection to the coast. Imagery from the U.S. Geological Survey – St. Petersburg Florida.

Figure 3: Typical pattern of loss on Chandealeur Islands from Hurricane Katrina
